Aaron Hakodesh

Reconstruction

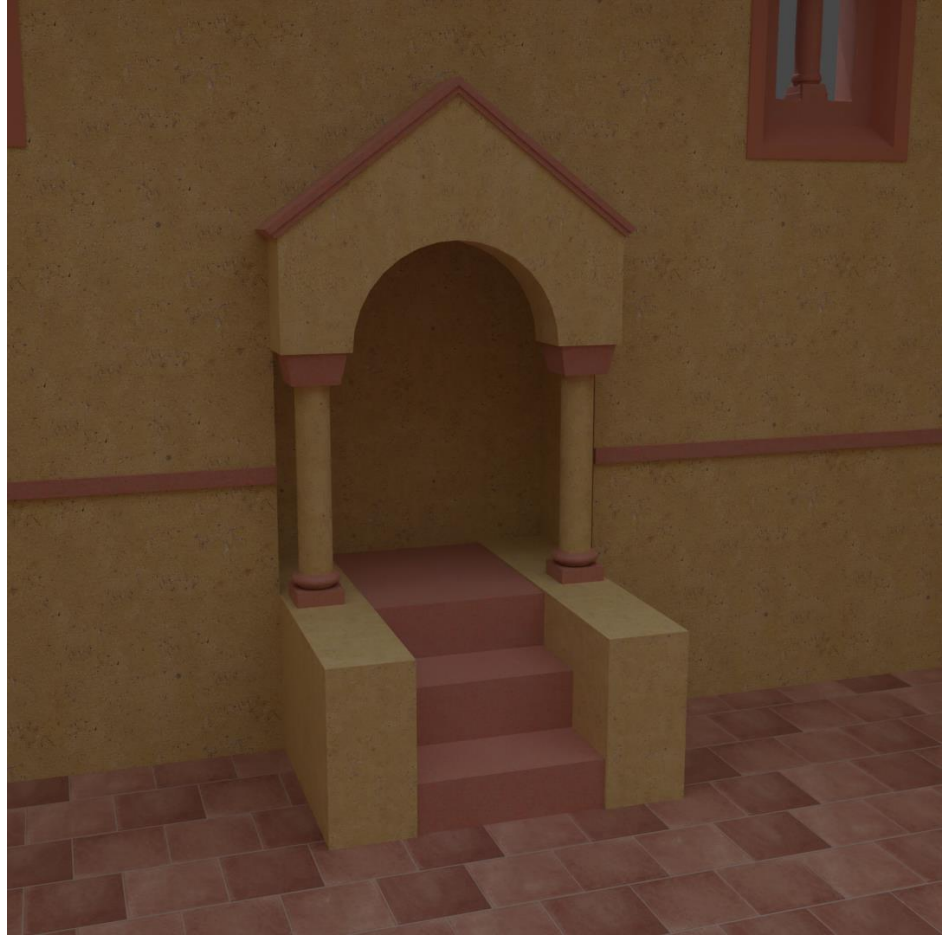
Uncertainty	The still standing wall shows remnants of the Aaron Hakodesh. The reconstruction has an Aaron Hakodesh which can be used as reference. There are some sources that show an Aaron Hakodesh from around a similar timeframe.	Level 2 (recess) Level 3 (columns, gabel, stairs)
Argumentation	The Aaron Hakodesh was modelled using the measurements provided in article_01 and the dimensions from the report_05. The overall shape was taken from the prior reconstruction.

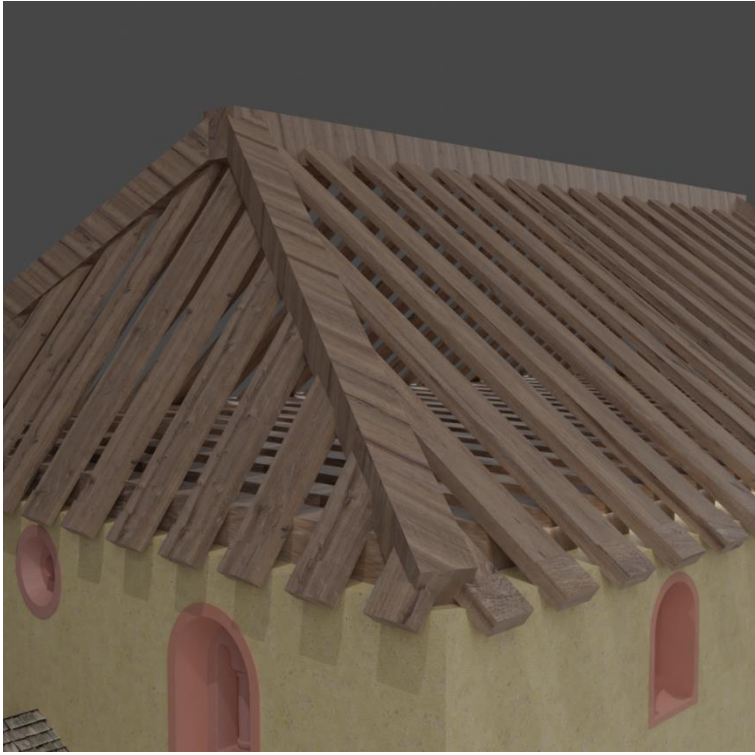
Beams 5a	
Reconstruction

Uncertainty	Nothing is left of the original roof at the site. There are also no other surviving roofs from that period. That also true for the beams.	Level 4
Argumentation	Hip roof beams were modelled. An array modifier was used to duplicate the beams and then a mirror modifier to mirror them along an axis. At the end some supporting beams were added to connect them all together.

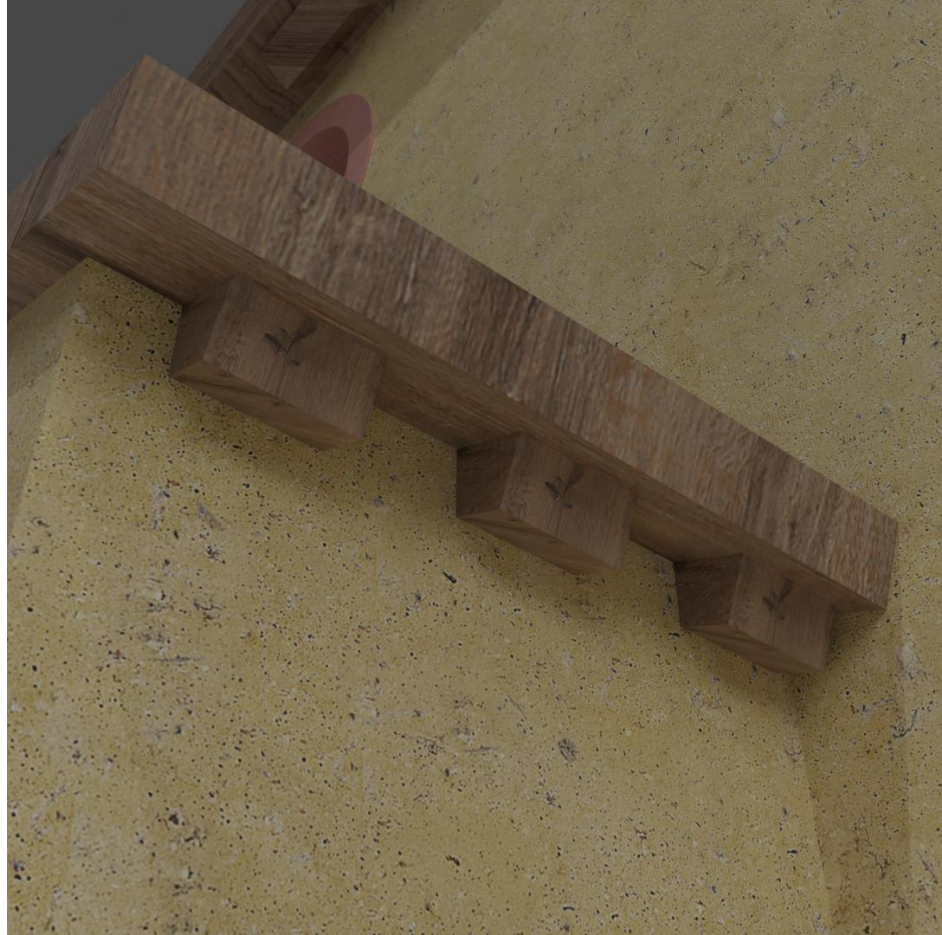
Beams 5b

Nothing is left of the original roof at the site. There are also no other surviving roofs from that period. That also true for the beams.

Gable

roof beams were modelled. An array modifier was used to duplicate the beams and then a mirror modifier to mirror them along an axis.
--	--

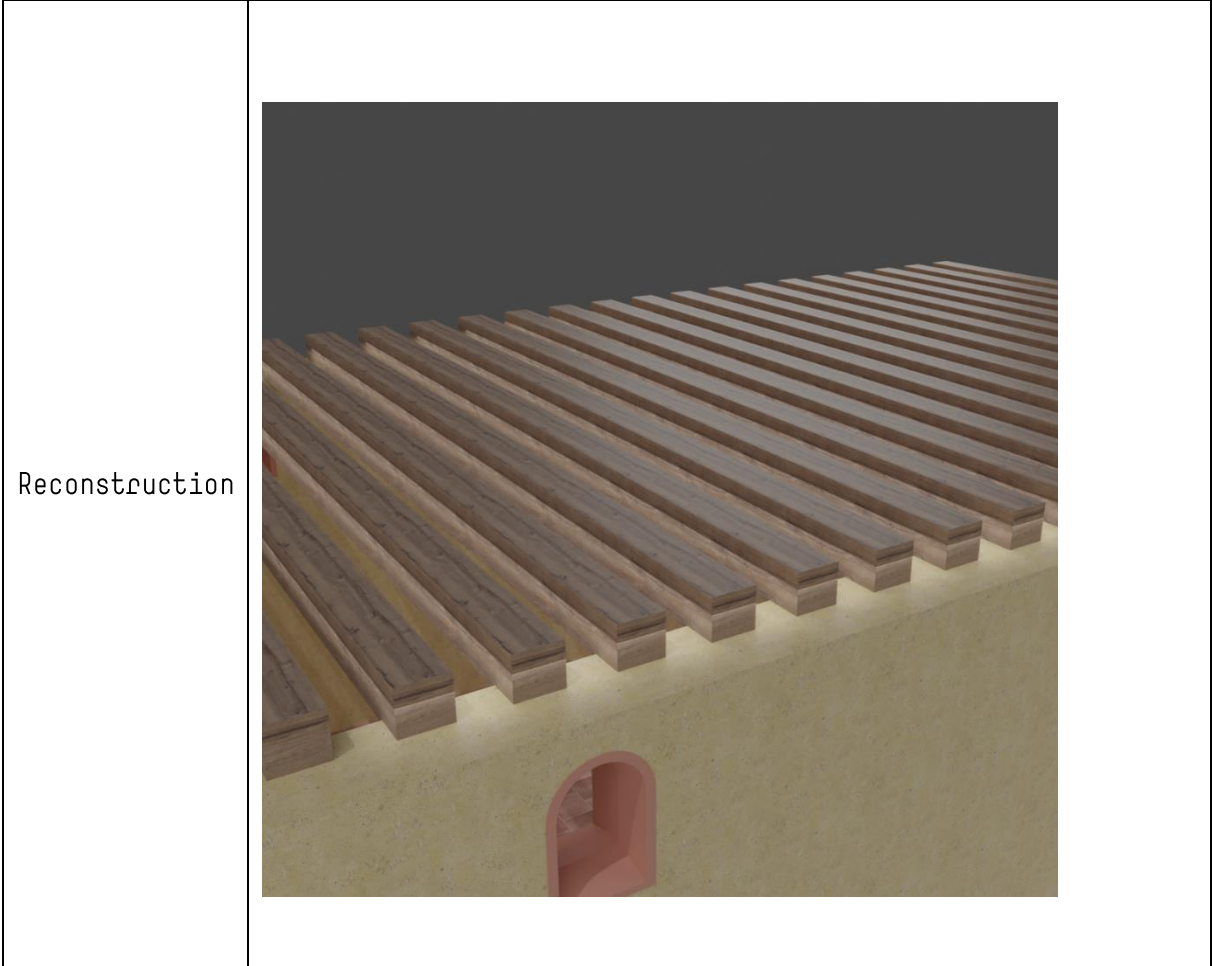
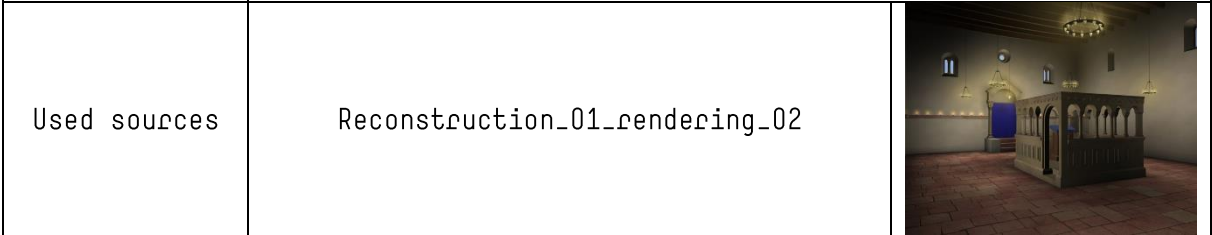
Beams 5c	
----------	--

Uncertainty	Nothing is left of the original roof at the site. There are also no other surviving roofs from that period. That also true for the beams.	Level 4
-------------	---	---------

Argumentation	Overarching beams were modelled to span the room. One beam was modelled and then copied via an array modifier.	
---------------	--	--

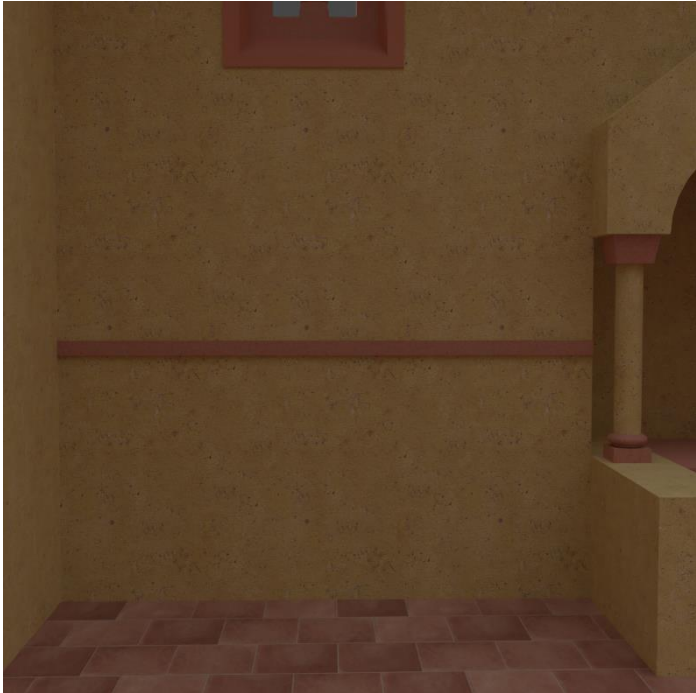
Cornice		
Reconstruction

Name of the source, <i>eg. Photo_location_02</i>	<i>Screenshot of the source</i>
Uncertainty	Parts of the cornice can still be found in the inside of the eastern wall.	Level 1
Argumentation	Added the cornice ledge at the appropriate height.

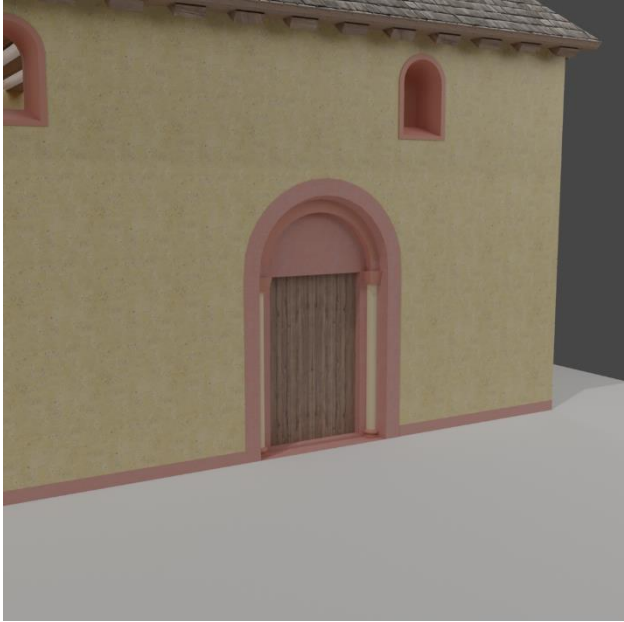
Entrance		
Reconstruction

Uncertainty	<p>The width of the entrance can still be found in the floor plan of report_04. There are analogies that can be referenced.</p>	<p>Level 3</p>

Argumentation	<p>A hole was cut out of the wall with a boolean. Then a cylinder was put in place and the bottom half removed. Pillars were added and the wooden door inserted.</p>

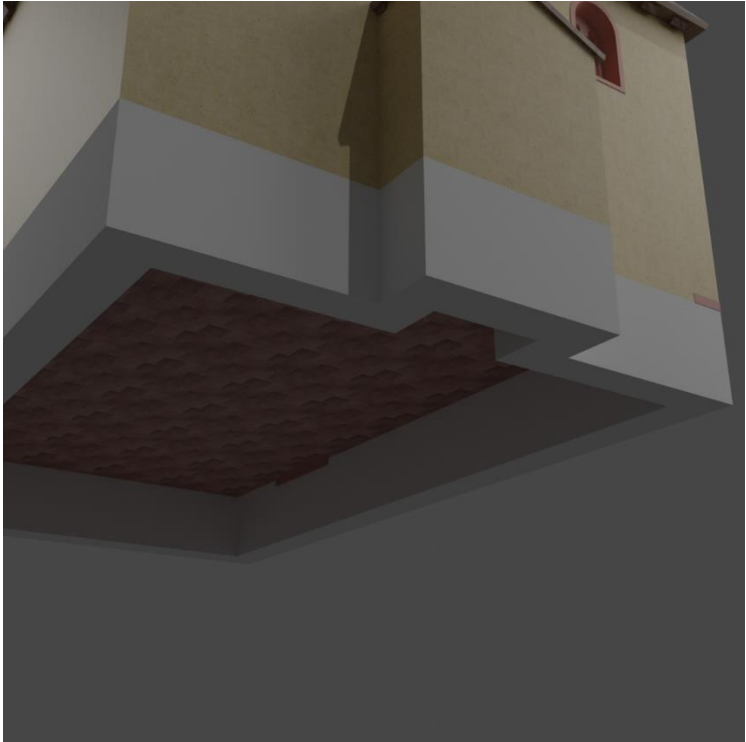
Foundation		
------------	--	--

Uncertainty	<p>Parts of the foundation were uncovered during the excavation and were recorded in report_05.</p>	Level 1
-------------	---	---------

Argumentation	<p>Used the floor plan for the layout of the foundation. Sadly the foundation is probably thicker than the walls, but there is no source showing this thickness.</p>	
---------------	--	--

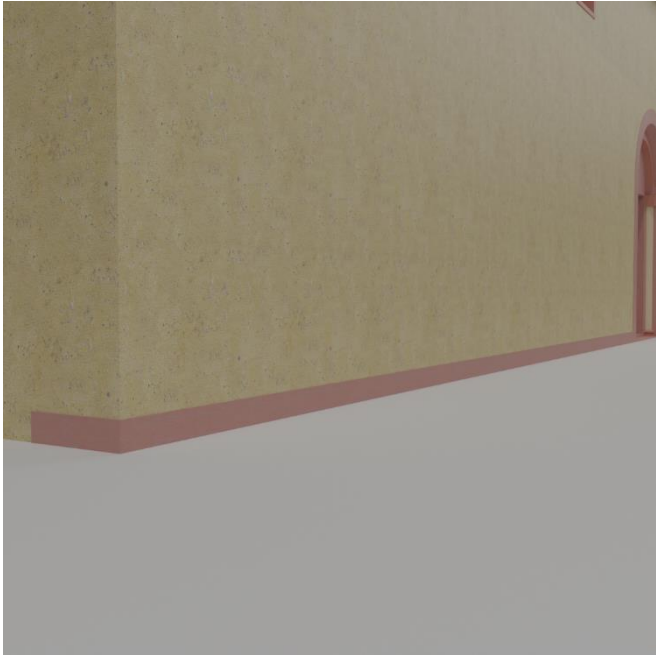
Plinth		
Reconstruction

Uncertainty	The plinth can be found at the site and is recorded in report_05.	Level 1
Argumentation	Was added later in the modelling process. A simple elongated cube.

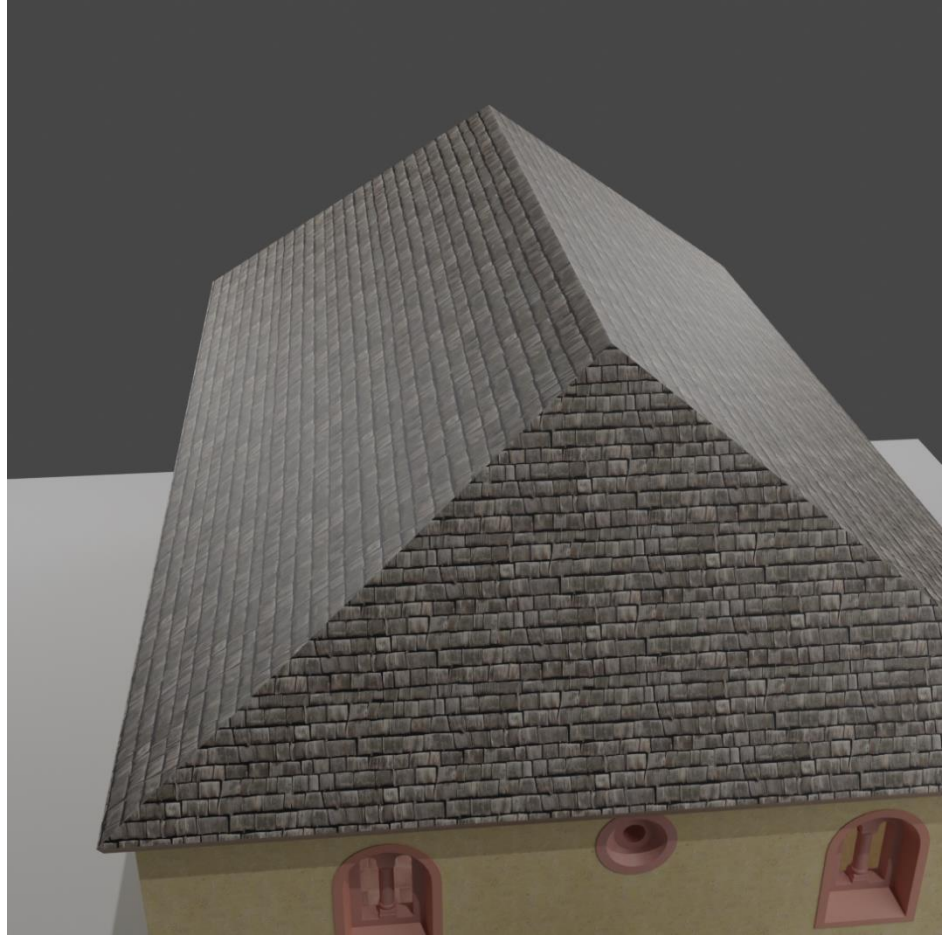
Roof 2a

<p>Uncertainty</p>	<p>Nothing is left of the original roof at the site. There are also no other surviving roofs from that period.</p>	<p>Level 4</p>
<p>Argumentation</p>	<p>A hip roof was modelled. It is the closest to the reconstructions.</p>

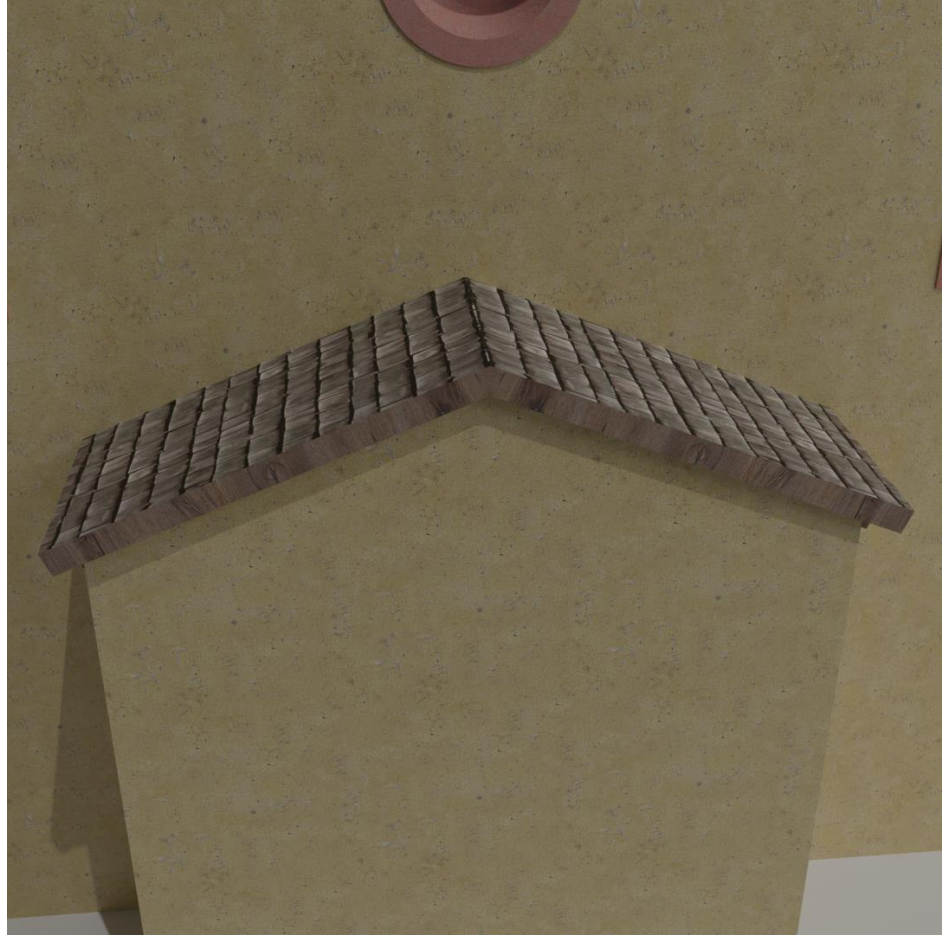
Roof 2b

<p>Uncertainty</p>	<p>Nothing is left of the original roof at the site. There are also no other surviving roofs from that period.</p>	<p>Level 4</p>
<p>Argumentation</p>	<p>A gable roof was modelled. It is the most likely covering of the extrusion.</p>

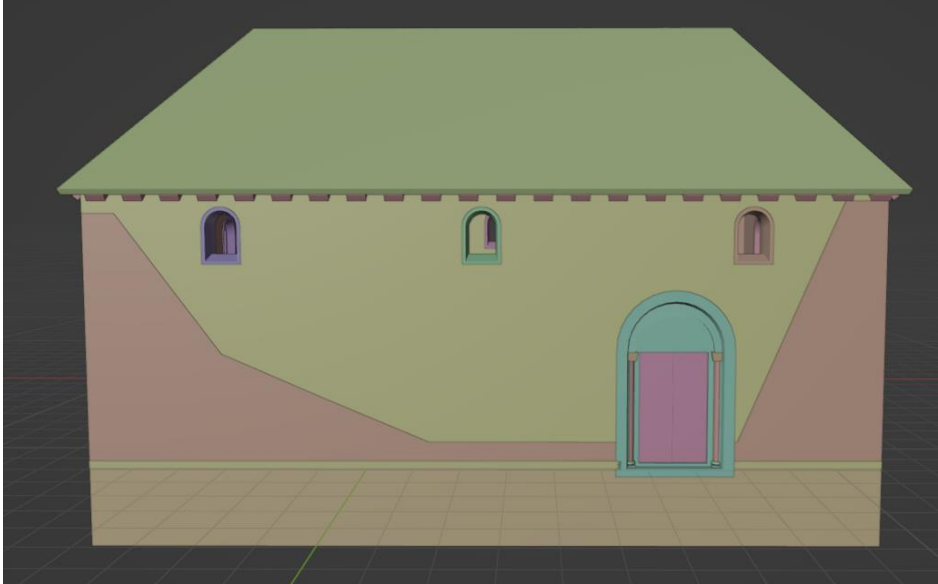
<p>Wall 1a</p>	
<p>Reconstruction</p>

Uncertainty	Parts of the wall can still be found at the location. The missing part of the wall needs to be reconstructed on that basis.	Level 1 (remaining walls) Level 2 (missing walls)
Argumentation	Most complicated part of the whole modelling process. The complete wall was modelled at the beginning. Later a boolean modifier was used to cut away the missing part of the wall and then filled up with a separate object.

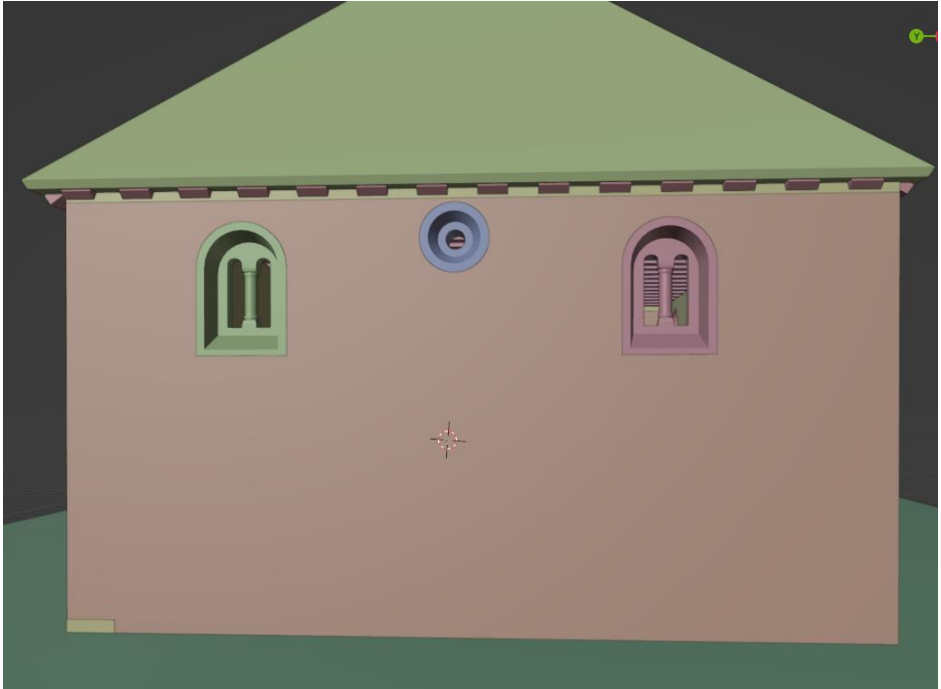
Wall 1b		
Reconstruction

Uncertainty	Parts of the wall can still be found at the location. The missing part of the wall needs to be reconstructed on that basis.	Level 1 (remaining walls) Level 2 (missing walls)
Argumentation	Most complicated part of the whole modelling process. The complete wall was modelled at the beginning. Later a boolean modifier was used to cut away the missing part of the wall and then filled up with a separate object.

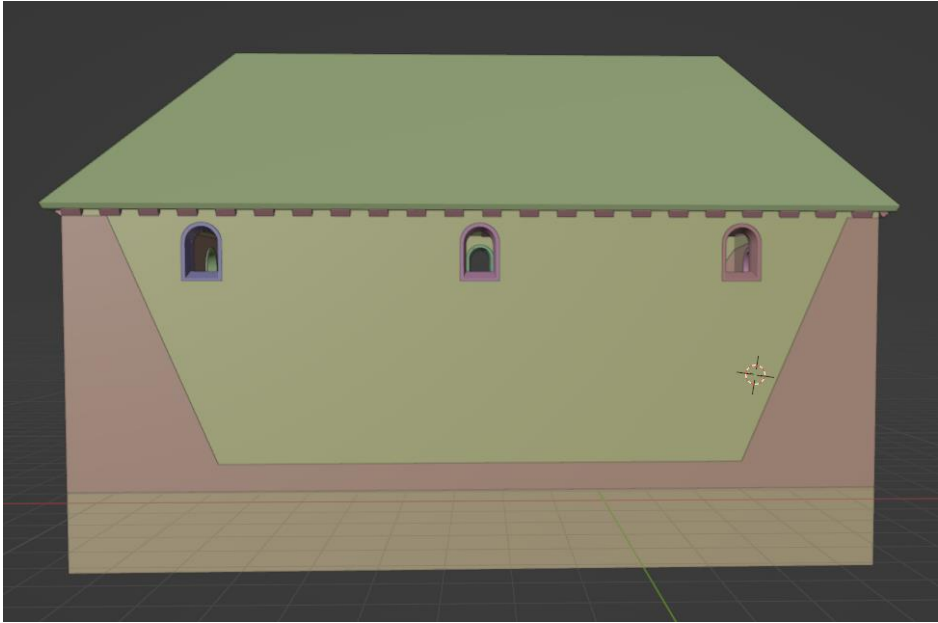
Wall 1c		
Reconstruction

Used sources	No sources provided?	
Uncertainty	Parts of the wall can still be found at the location. The missing part of the wall needs to be reconstructed on that basis.	Level 1 (remaining walls) Level 2 (missing walls)
Argumentation	Most complicated part of the whole modelling process. The complete wall was modelled at the beginning. Later a boolean modifier was used to cut away the missing part of the wall and then filled up with a separate object.

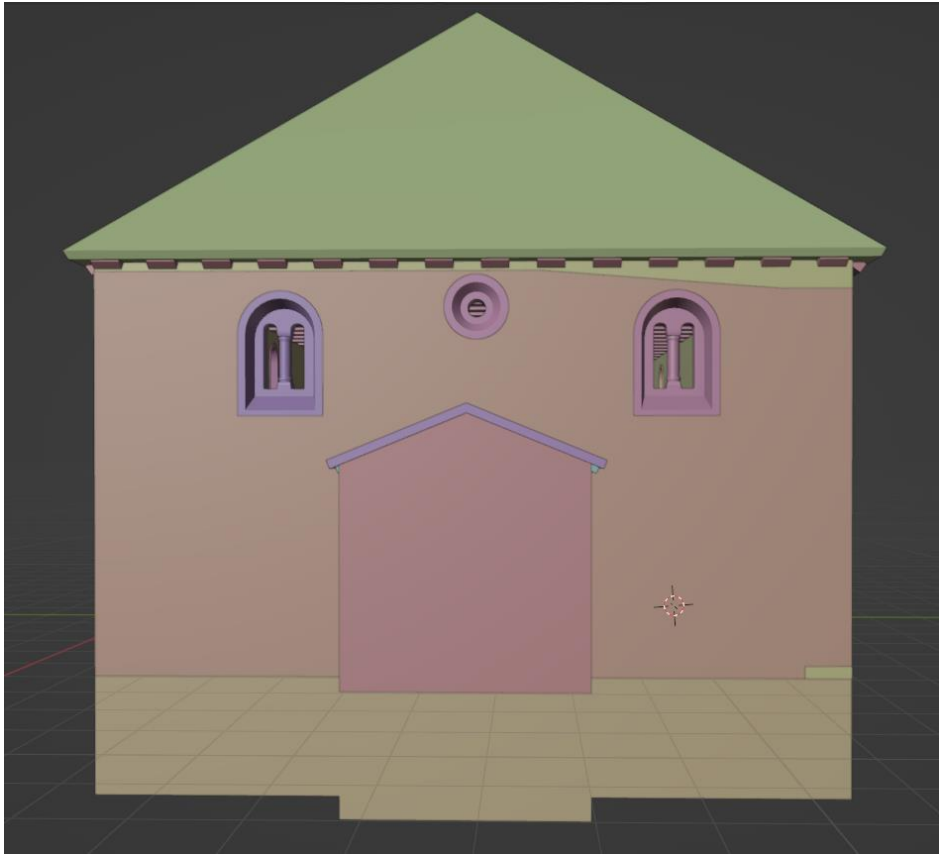
Wall 1d

Parts of the wall can still be found at the location. The missing part of the wall needs to be reconstructed on that basis.

Most complicated part of the whole modelling process. The complete wall was modelled at the beginning. Later a boolean

modifier was used to cut away the missing part of the wall and then filled up with a separate object.

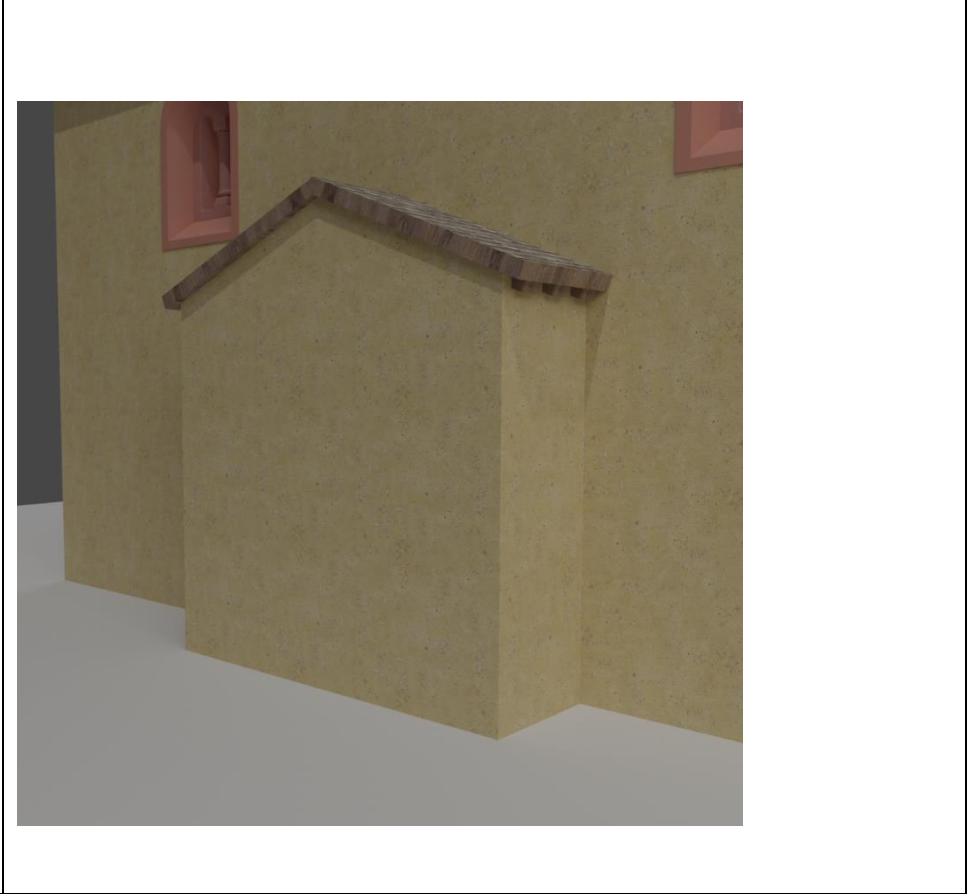
Wall 1e

The foundation of the extrusion still survives today. The dimensions can be gleaned from both the reports above.

Argumentation	All the walls were extruded upwards from the dimensions of the report. The wall 1e was only extruded up to the height found in report_05 together with the estimated height of the Aaron Hakodesh.

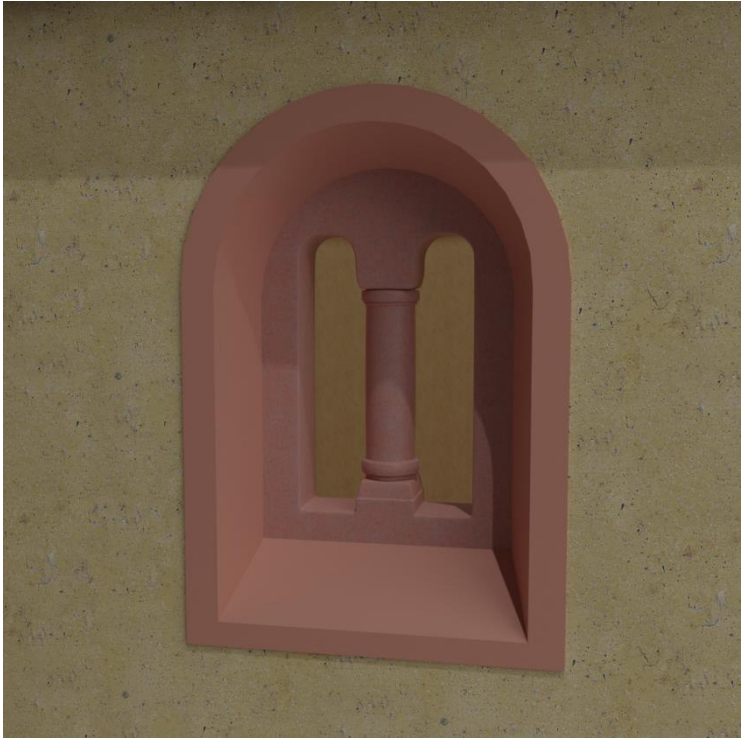
Window 8a		
Reconstruction

Uncertainty	The windows are still embedded into the wall, and an additional set is displayed at the museum.	Level 1
Argumentation	<p>First the sources were added to Blender as reference pictures. To be able to get the form of the column and its connection right, a subsurface modifier was added. This makes this the object with by far the most vertices. Which also makes it the object that took the longest to model.</p>

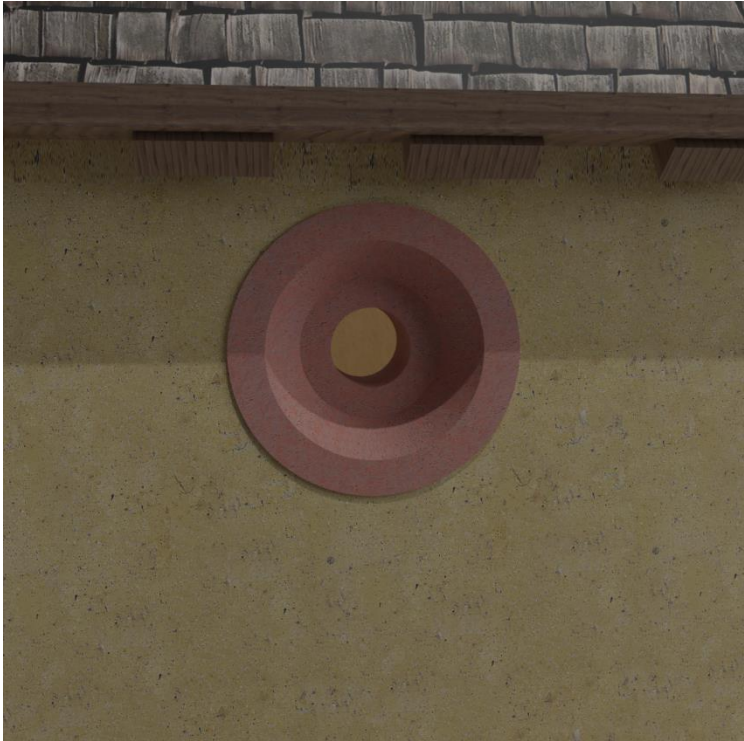
Window 8b		
Reconstruction

Uncertainty	The windows can still be found in the walls.	Level 1
Argumentation

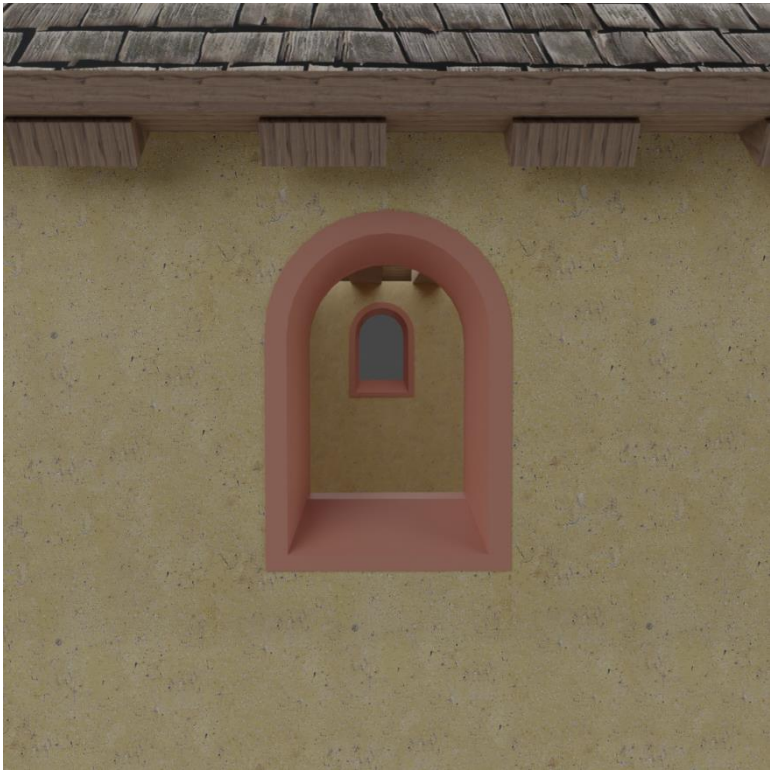
Window 8c		
Reconstruction

Uncertainty	The windows cannot be found in the still standing walls, or in the archaeological report. The only source for this project are the prior made renders.	Level 4
Argumentation	For these windows the 8a windows were used, and then scaled down to fit the openings. The position and amount were taken from the reconstructions. No major problems during modelling.
