Synagogue in Janów Sokólski

Description

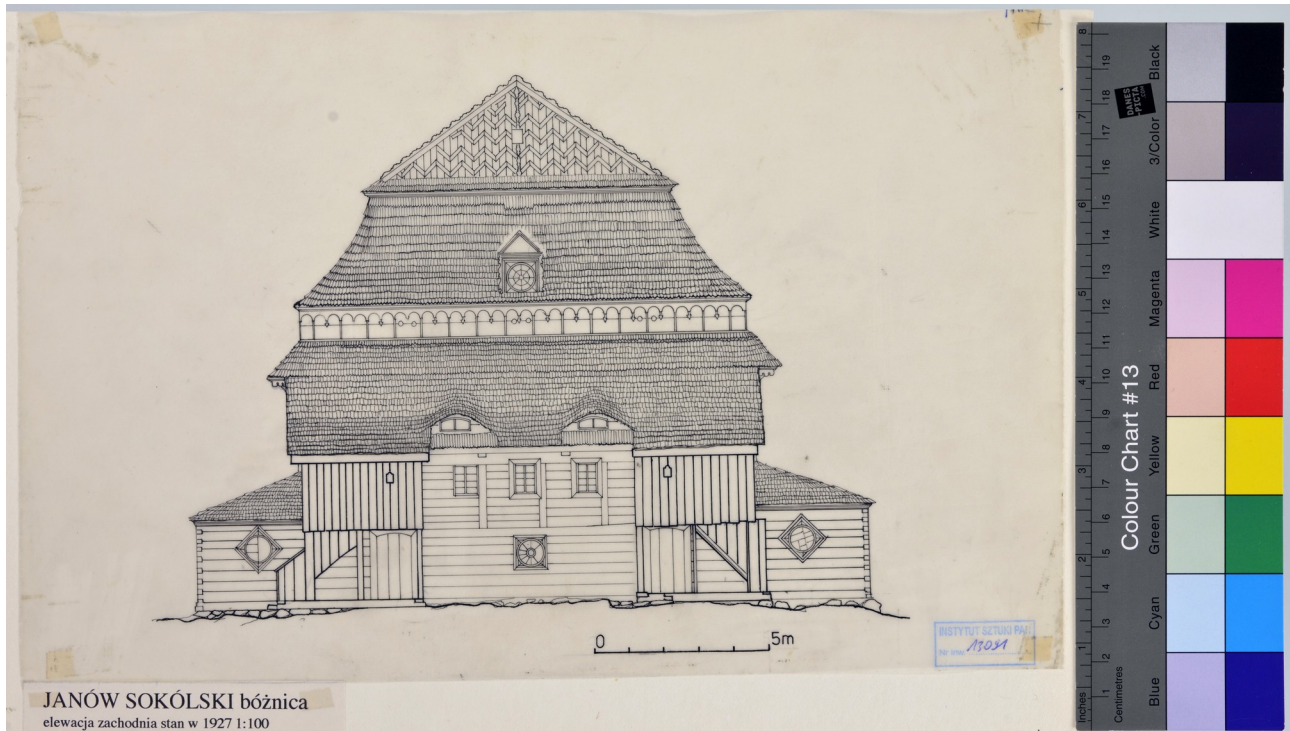
Fig. 2 West elevation

Description West Elevation

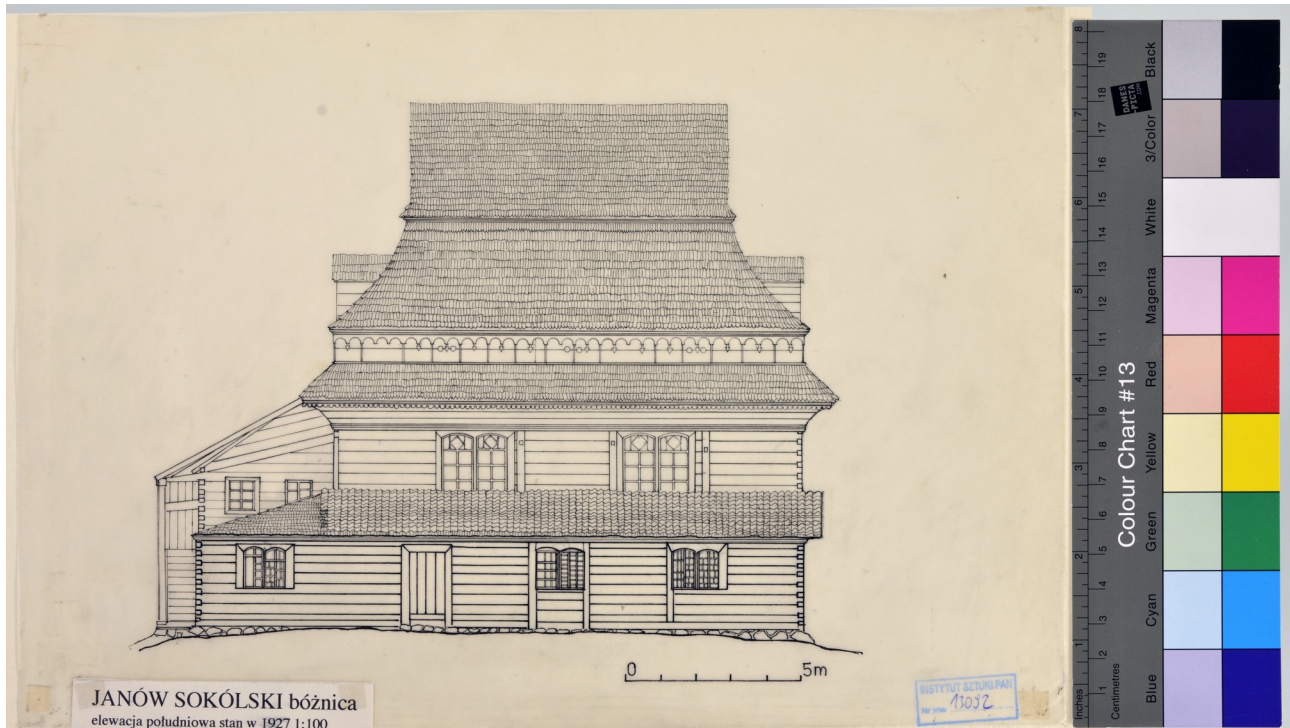
Fig. 3 South elevation

Description South Elevation

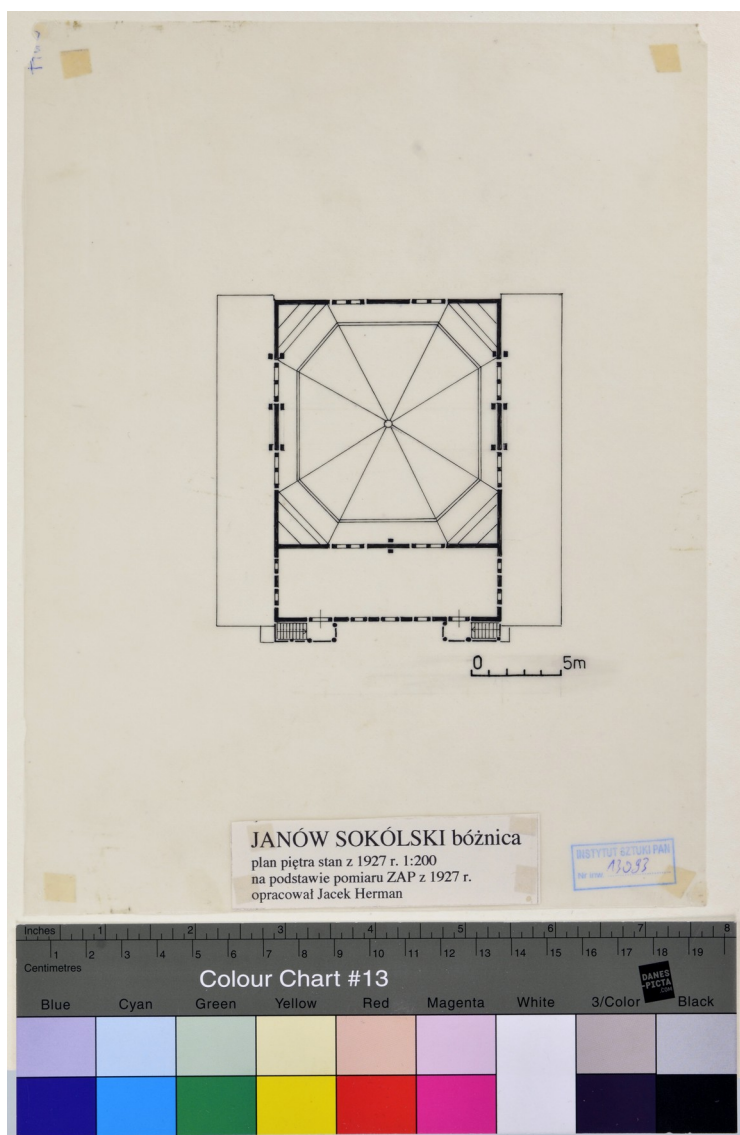
Fig. 4 Roof plan after superstructure of the granary

Description First floor plan

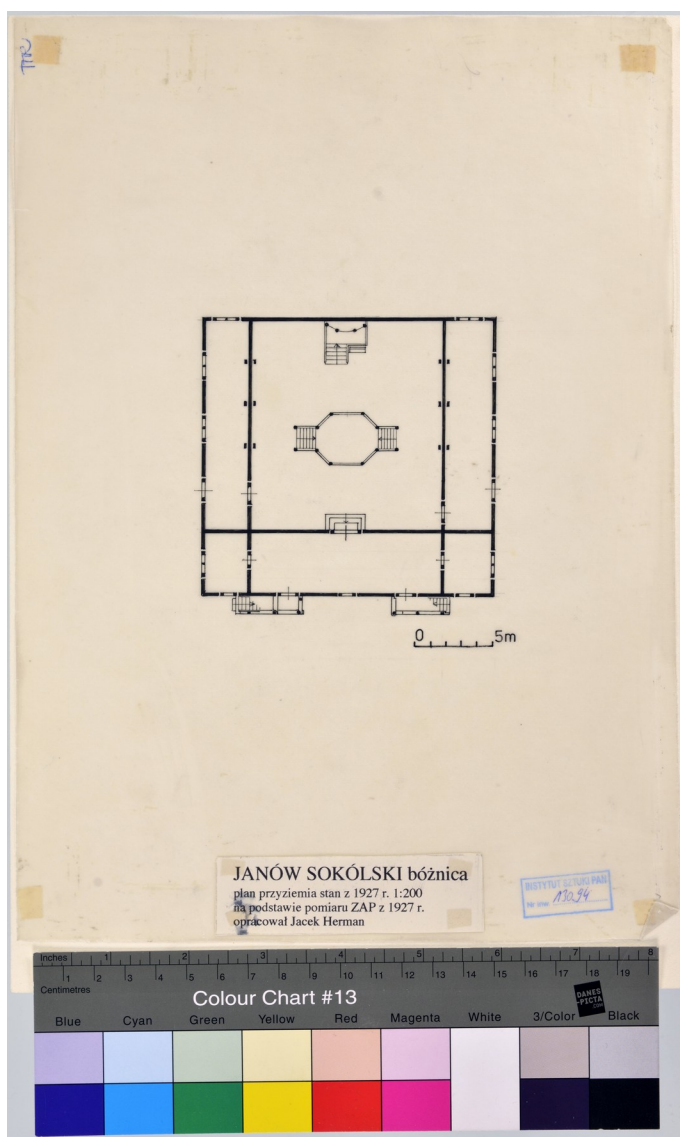
Fig. 5 Plan with an over-built granary

Description Ground floor plan

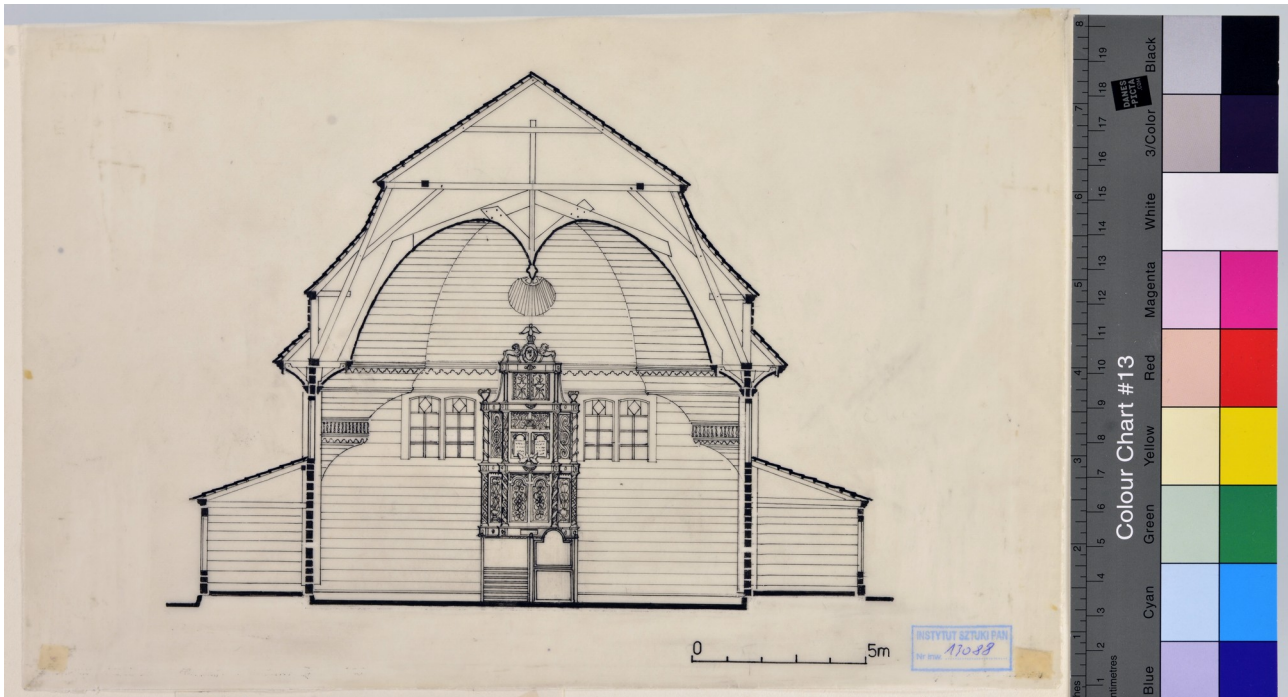
Fig. 6 East elevation overlooking the aron ha-kodesh

Description Cross section overlooking aron ha-kodesh

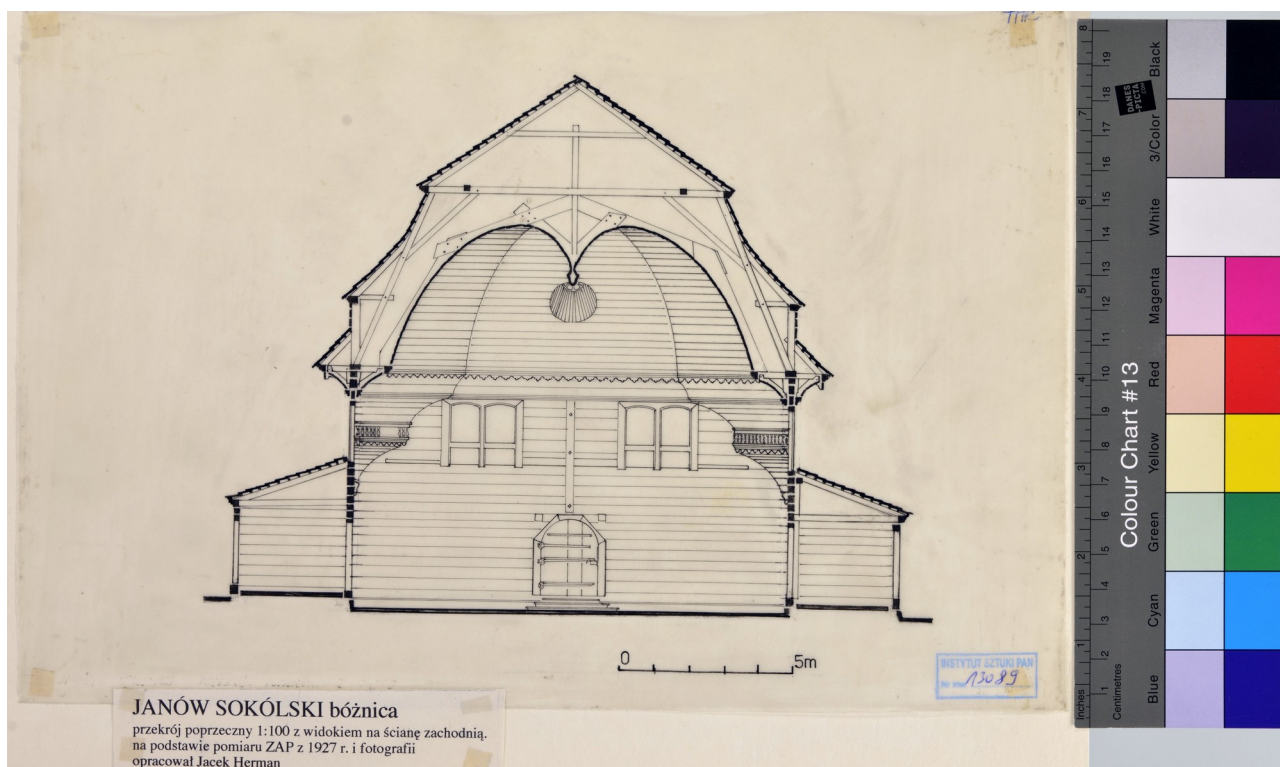
Fig. 7 View of the west elevation from the inside

Description Cross-section

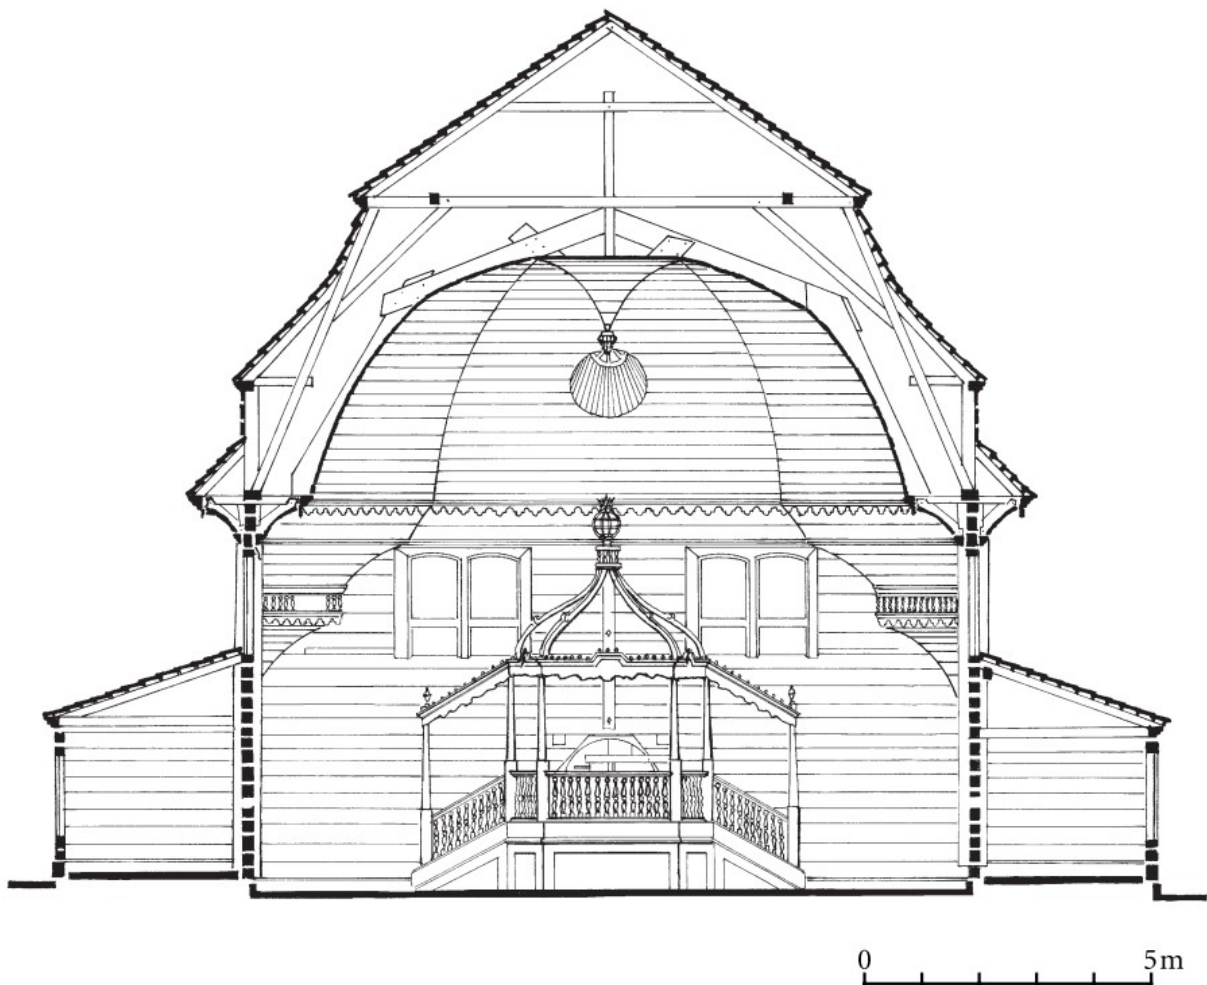
Fig. 8 View of the west elevation from the inside including the bima

Description Cross section overlooking the bima

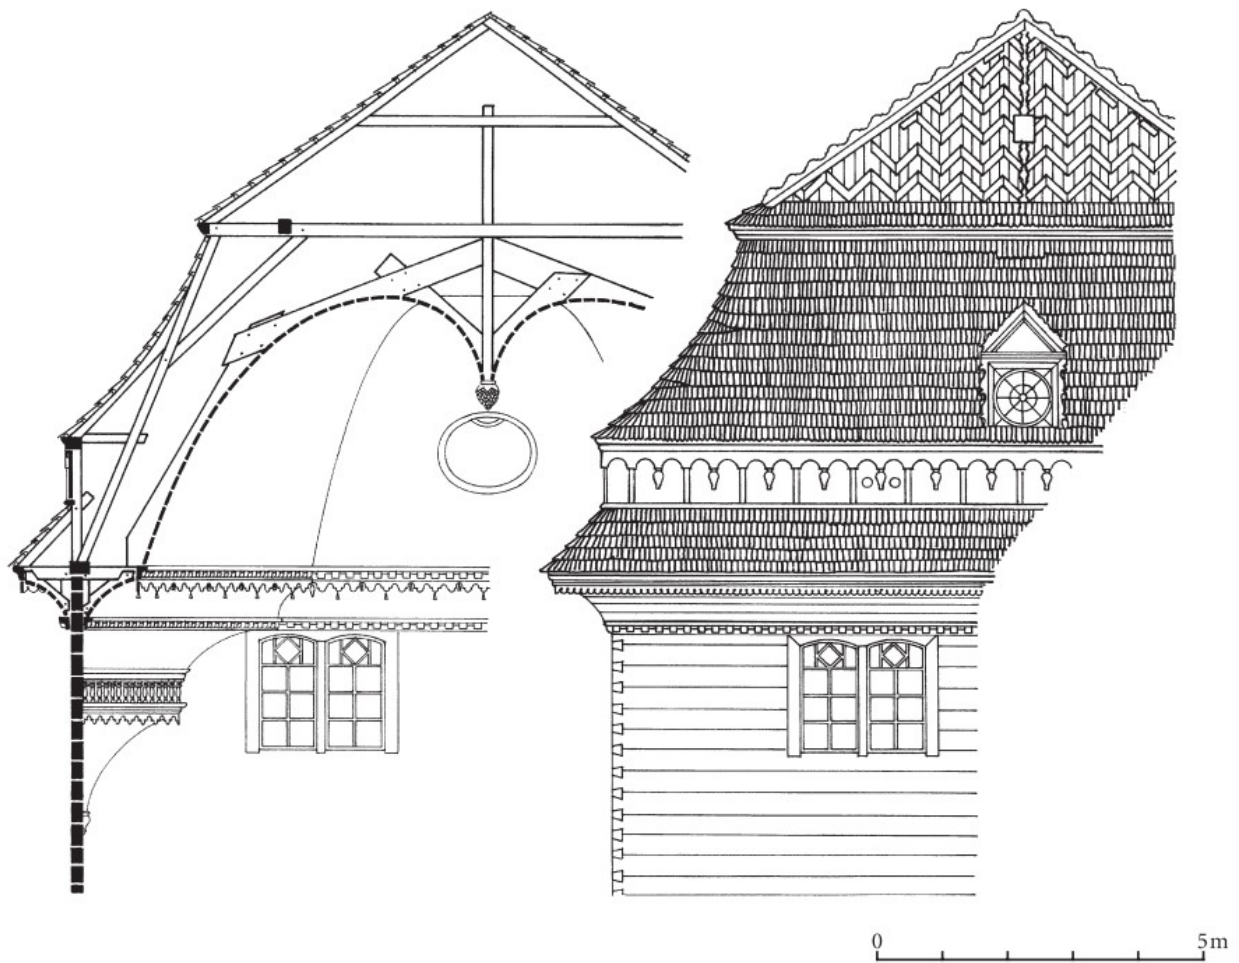
Fig. 13 West Elevation and section

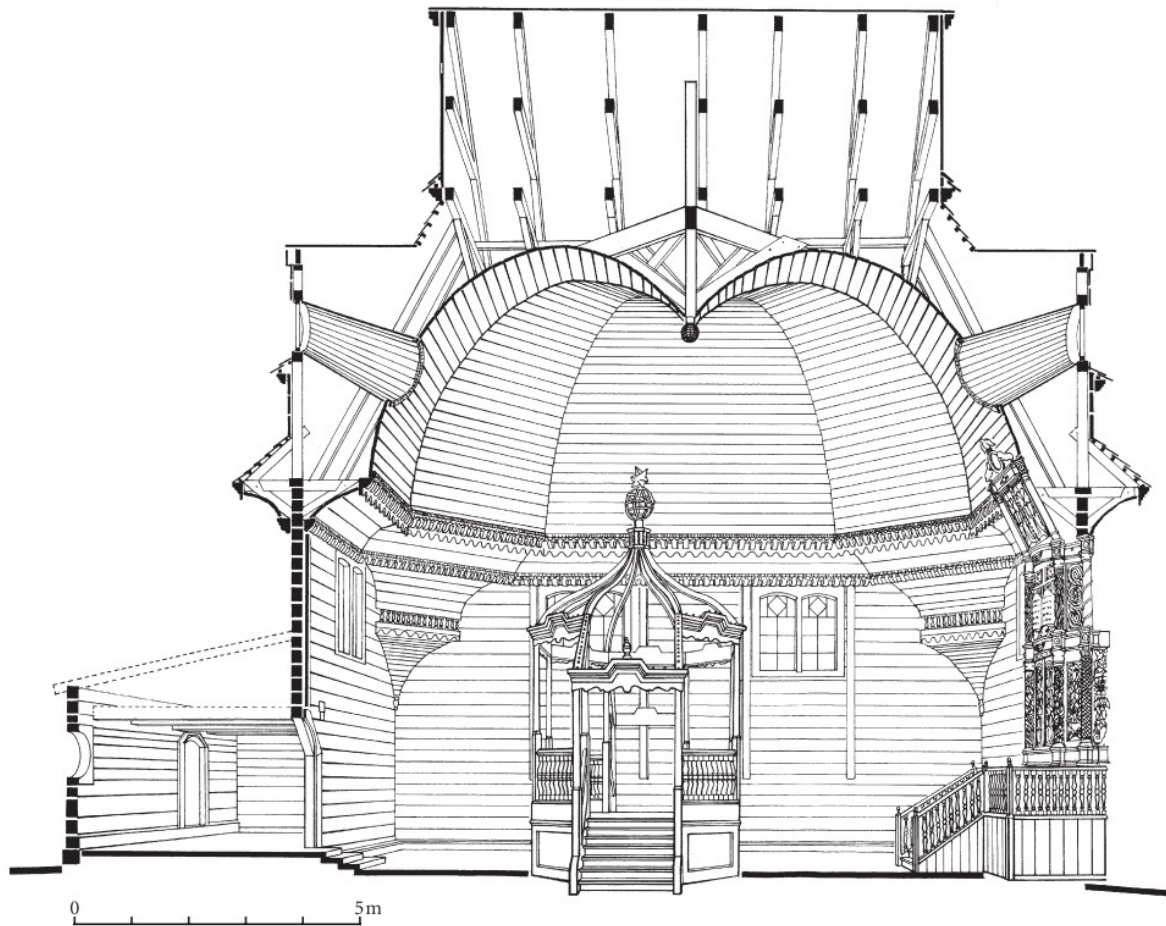
Fig. 14 cross section overlooking the aron ha-kodesh

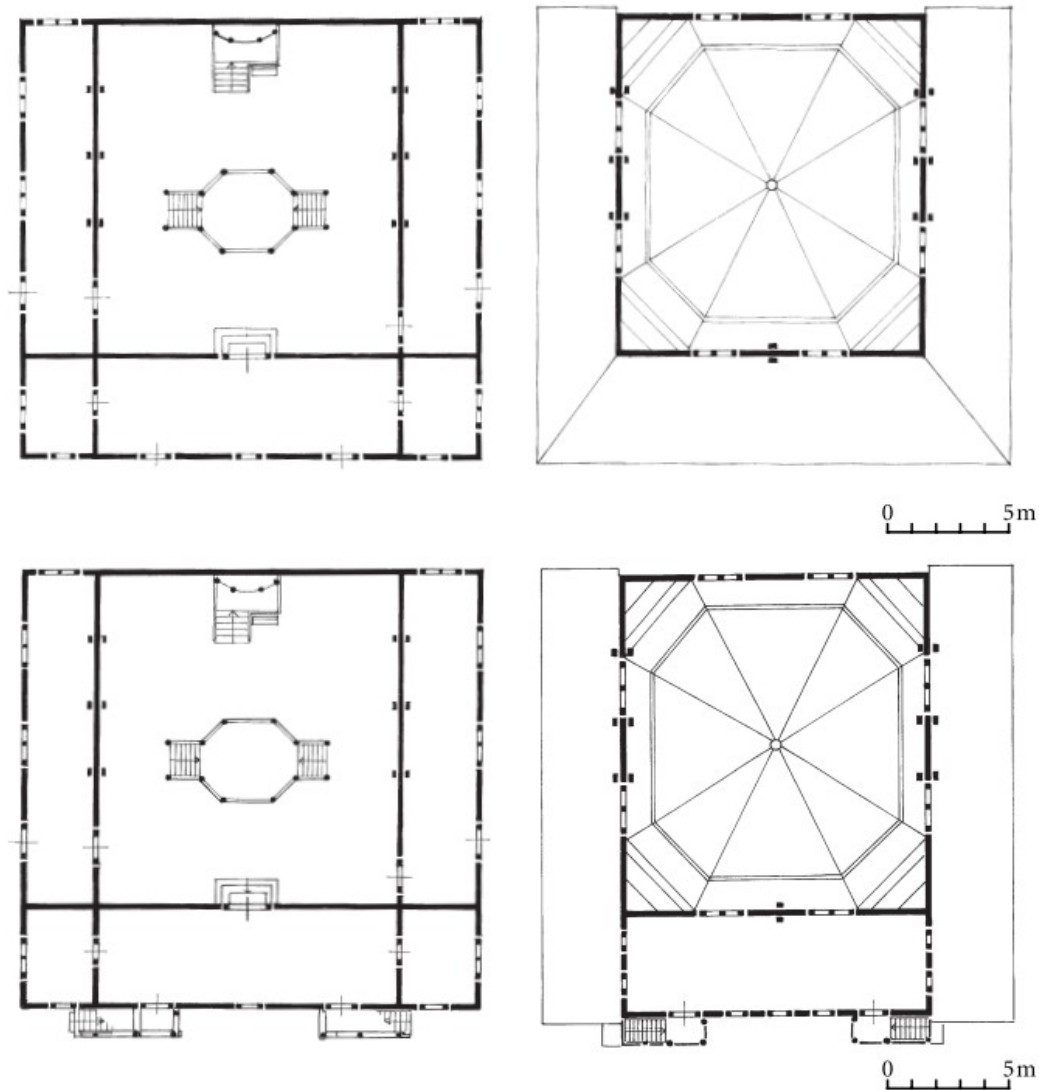
Fig. 18 floor and roof plans

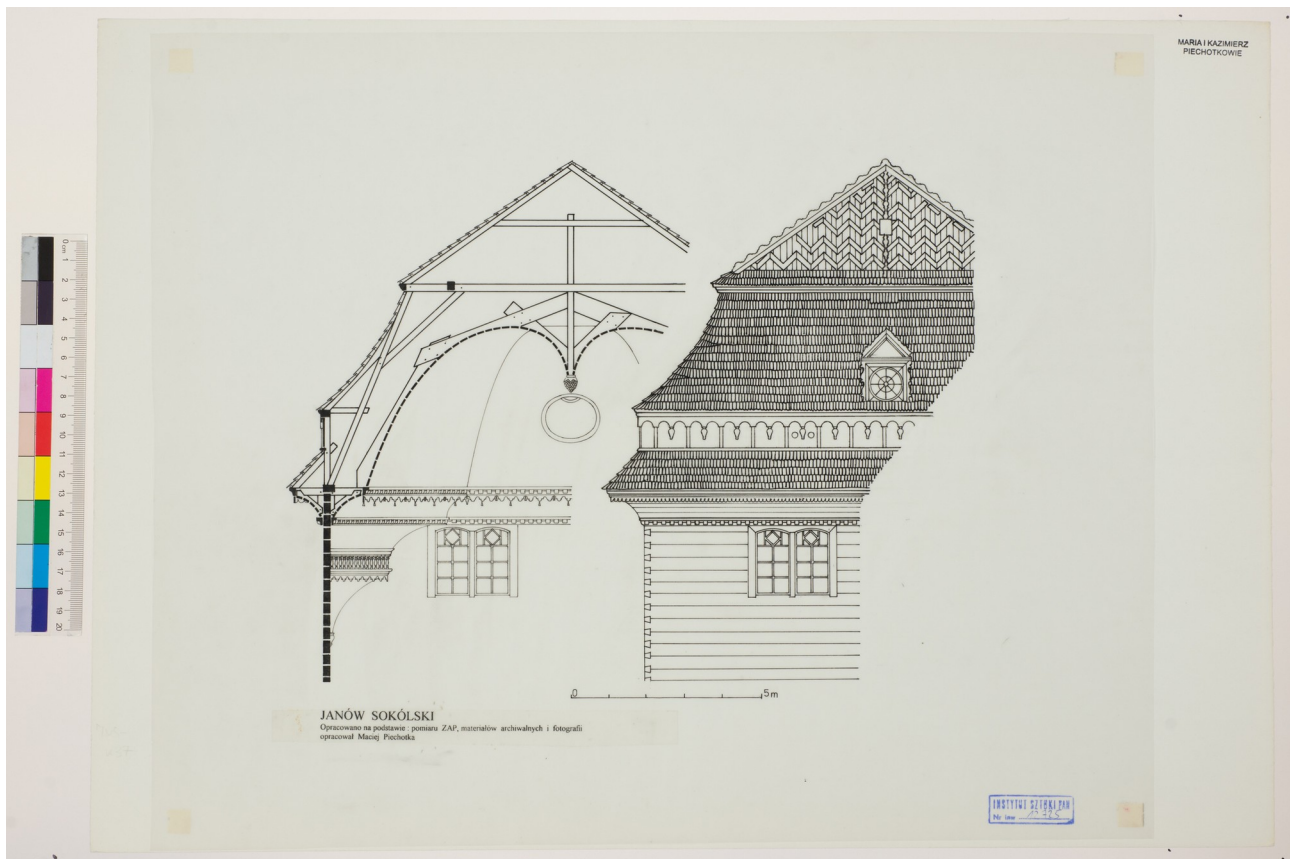
Fig. 32 East elevation and section

Description Mansard truss
