Worms 1200 – Domarea

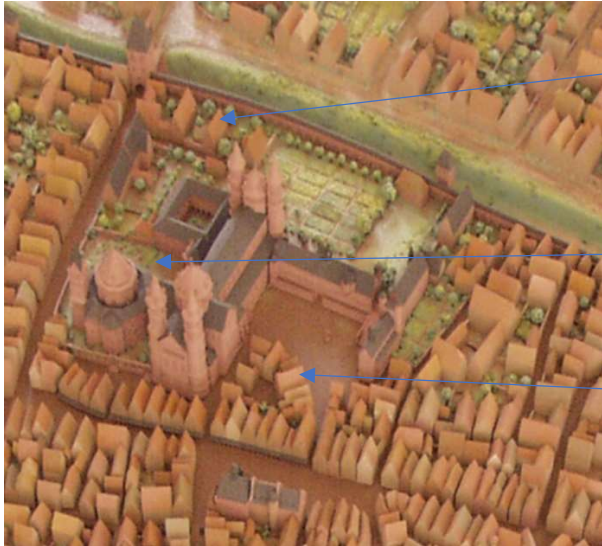
Kurien houses or estate houses of the Domstift.

Graveyard should be here.

This street line comes from the Hamman map, from around

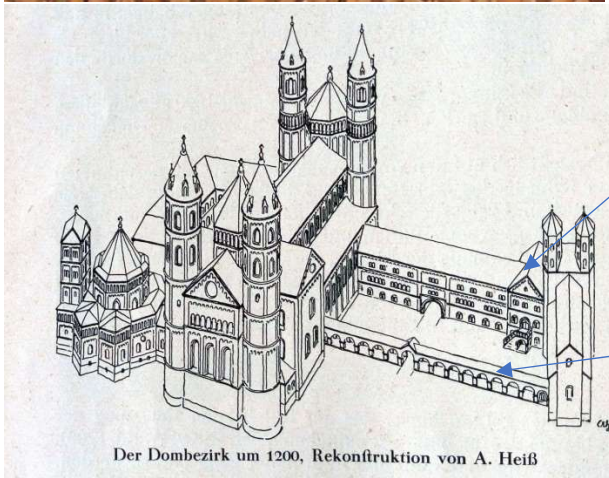
Der Dombezirk um 1200, Rekonstruktion von A. Heiß

The form of this part, is controversial.

Wall is controversial.

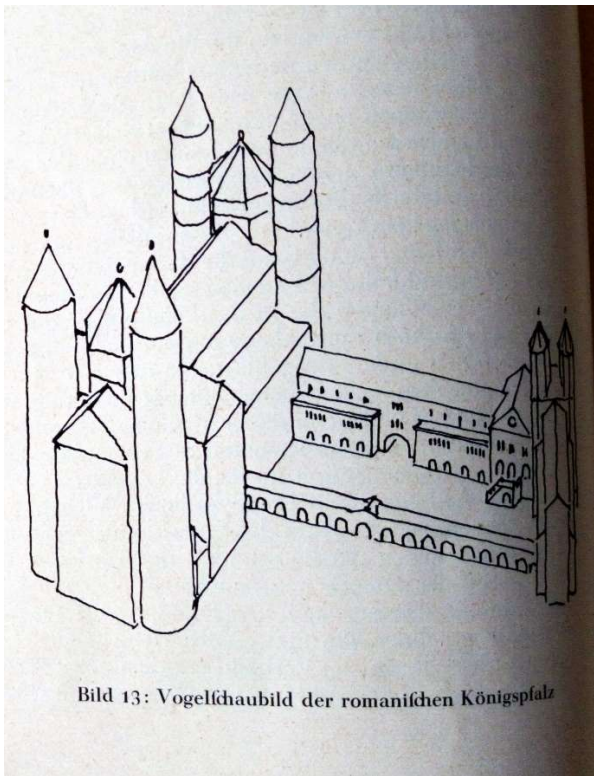
Bild 13: Vogelfchaubild der romanischen Königspfalz

Documented is that the palace had three storeys: groundfloor (around 3,5 m high), main floor 4,5 m high) and Second floor (3,5 m high).

Sketch of romanic Pfalz (around 1000/1100?).

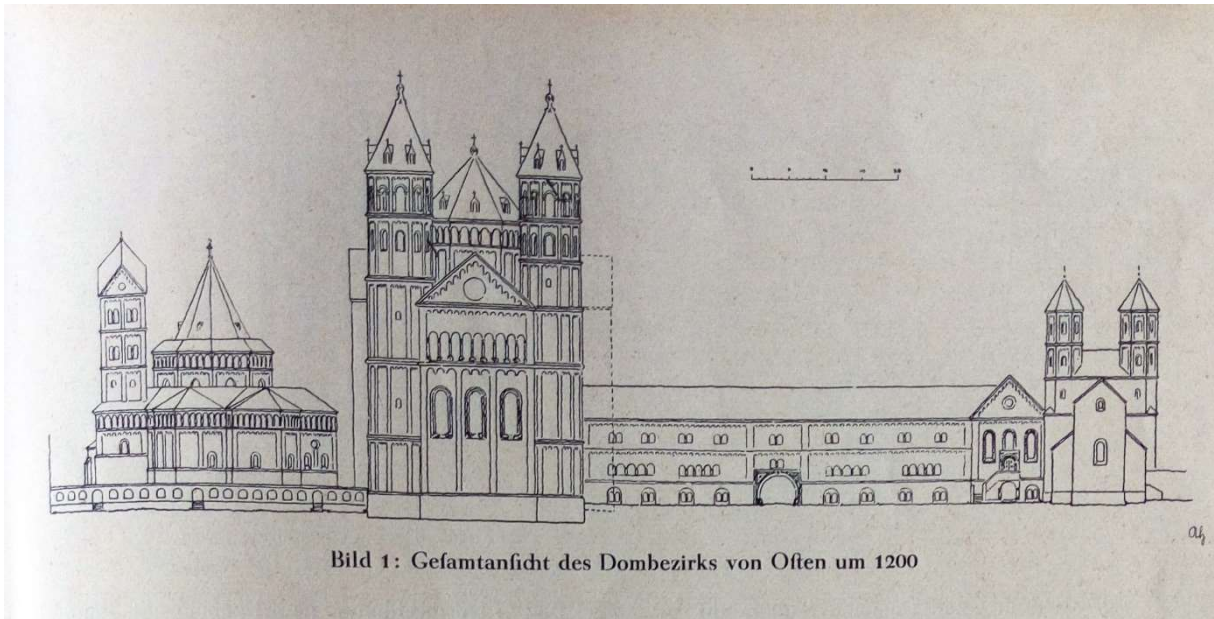
Bild 1: Gesamtansicht des Dombezirks von Osnabrück um 1200

Total View of Dom area from the East around 1200 (Reconstruction)

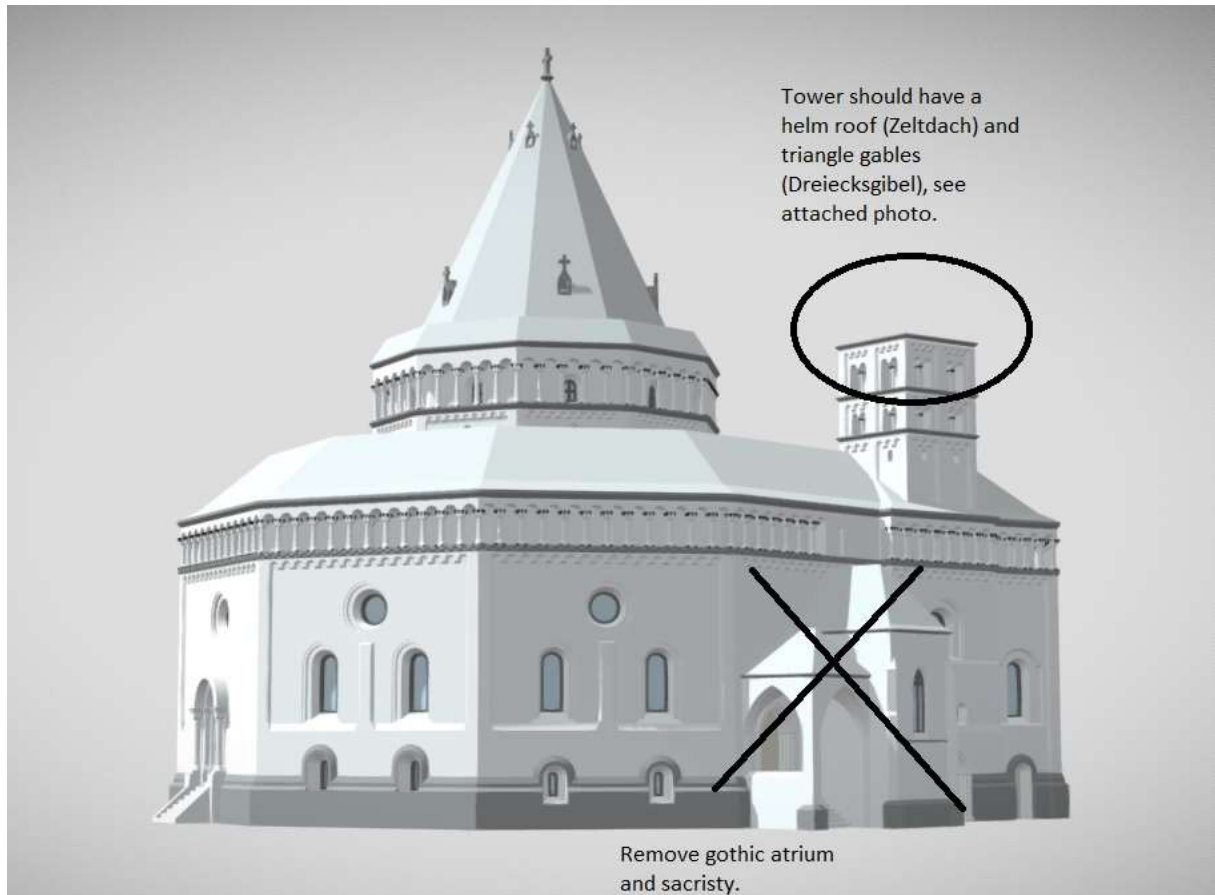
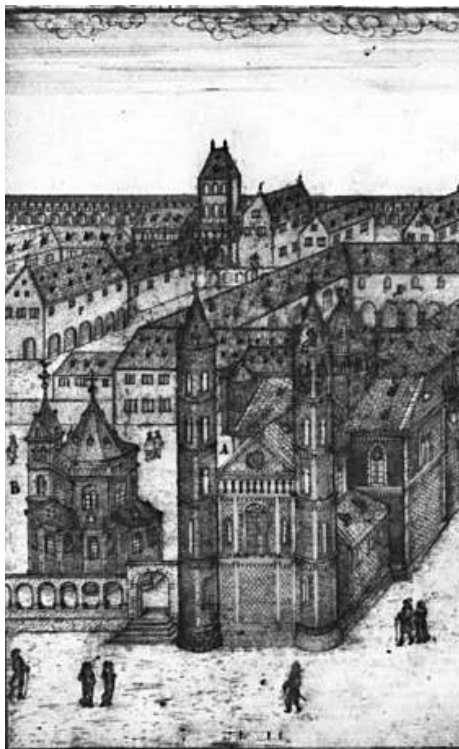
St. Johannes

Corrections by Julian Hanschke
